WOOD DESTROYING PESTS AND ORGANISMS INSPECTION REPORT

Report # 120017

General Description: Single Family Residence, 2 Story, Vacant	Inspection Tag Posted: Water Heater Closet
	Other Tags Posted: No Other Tags Noted

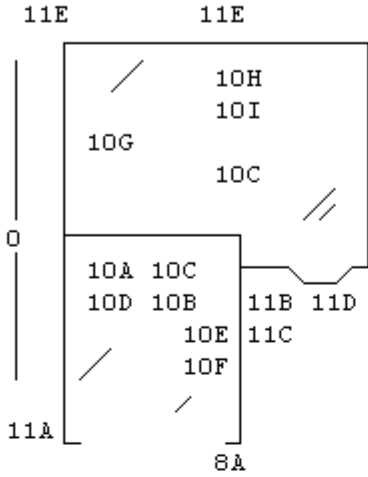
An inspection has been made of the structure(s) shown on the diagram in accordance with the Structural Pest Control Act. Detached porches, detached steps, detached decks and any other structures not on the diagram were not inspected.
